**Final
Site Specific Work Plan
Phase I RCRA Facility Investigation
Atlantic Fleet Weapons Training Facility
Vieques Island, Puerto Rico**

Prepared for
**Department of the Navy
Atlantic Division
Naval Facilities Engineering Command**

Prepared by
CH2MHILL
Tampa, Florida

February 2001

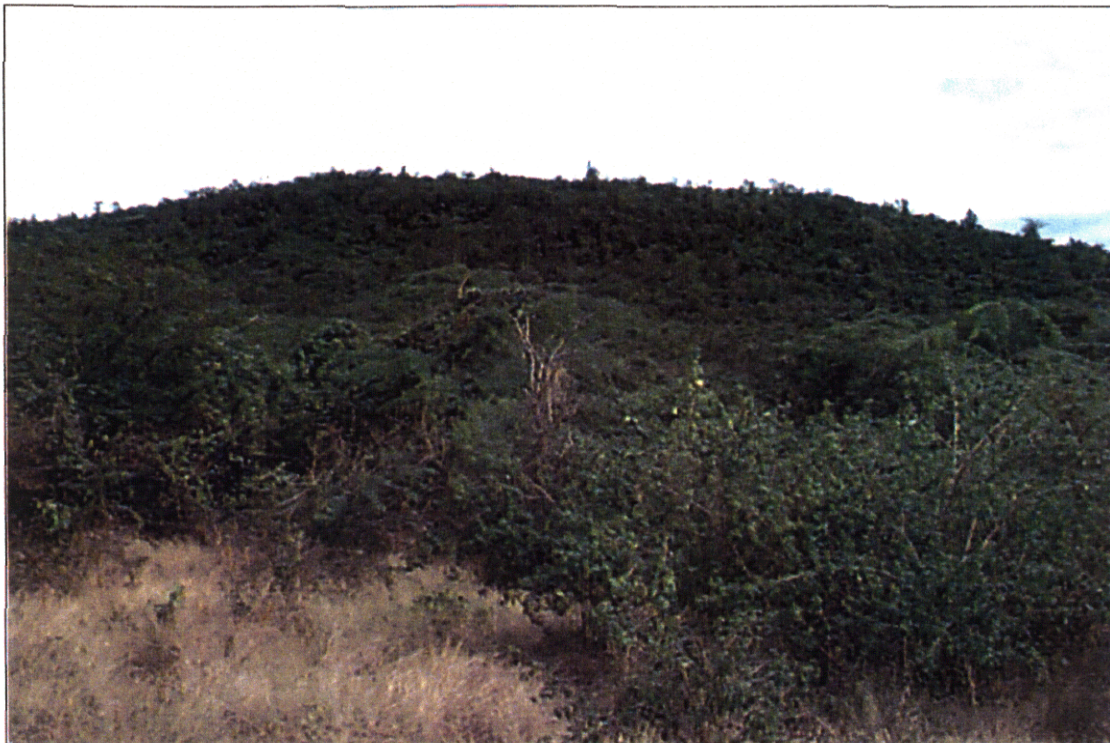
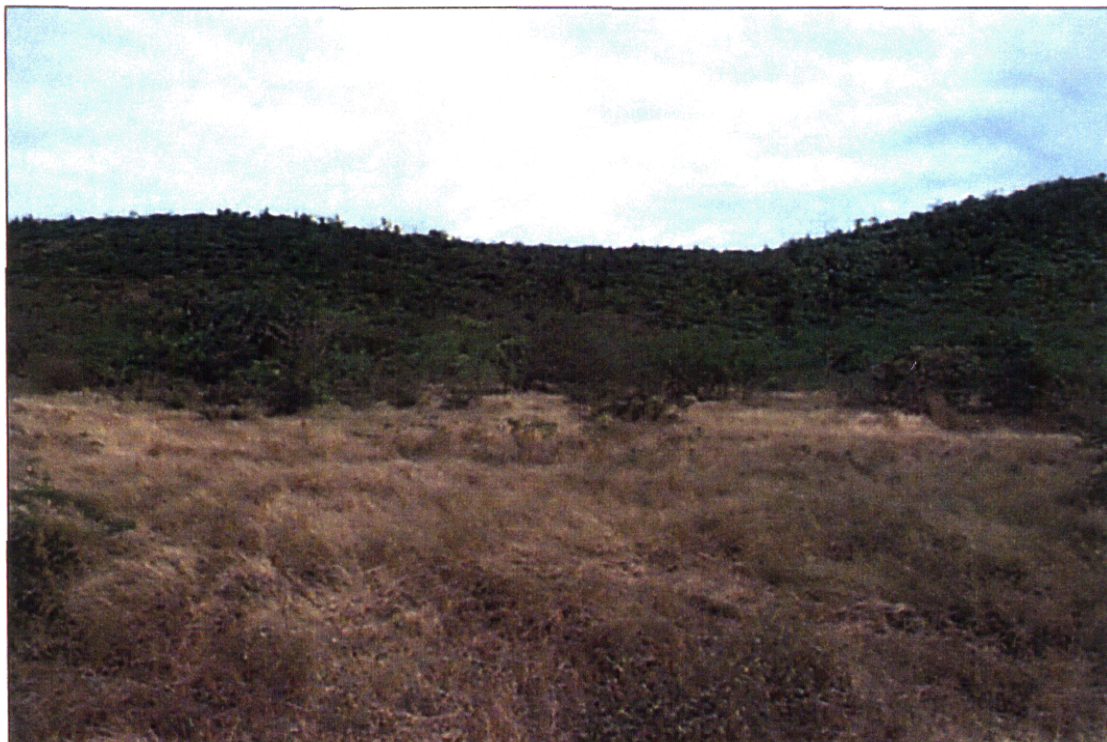
Figure 2-1
SWMU 01 CAMP GARCIA LANDFILL
Vieques Island, Puerto Rico

During the February 2000 CH2M HILL site visit, no signs of previous landfill activities were visible at the site. The site was heavily vegetated (see Figure 2-1).

SWMU-1: Camp Garcia Landfill, Looking West

SWMU-1: Camp Garcia Landfill, Looking East

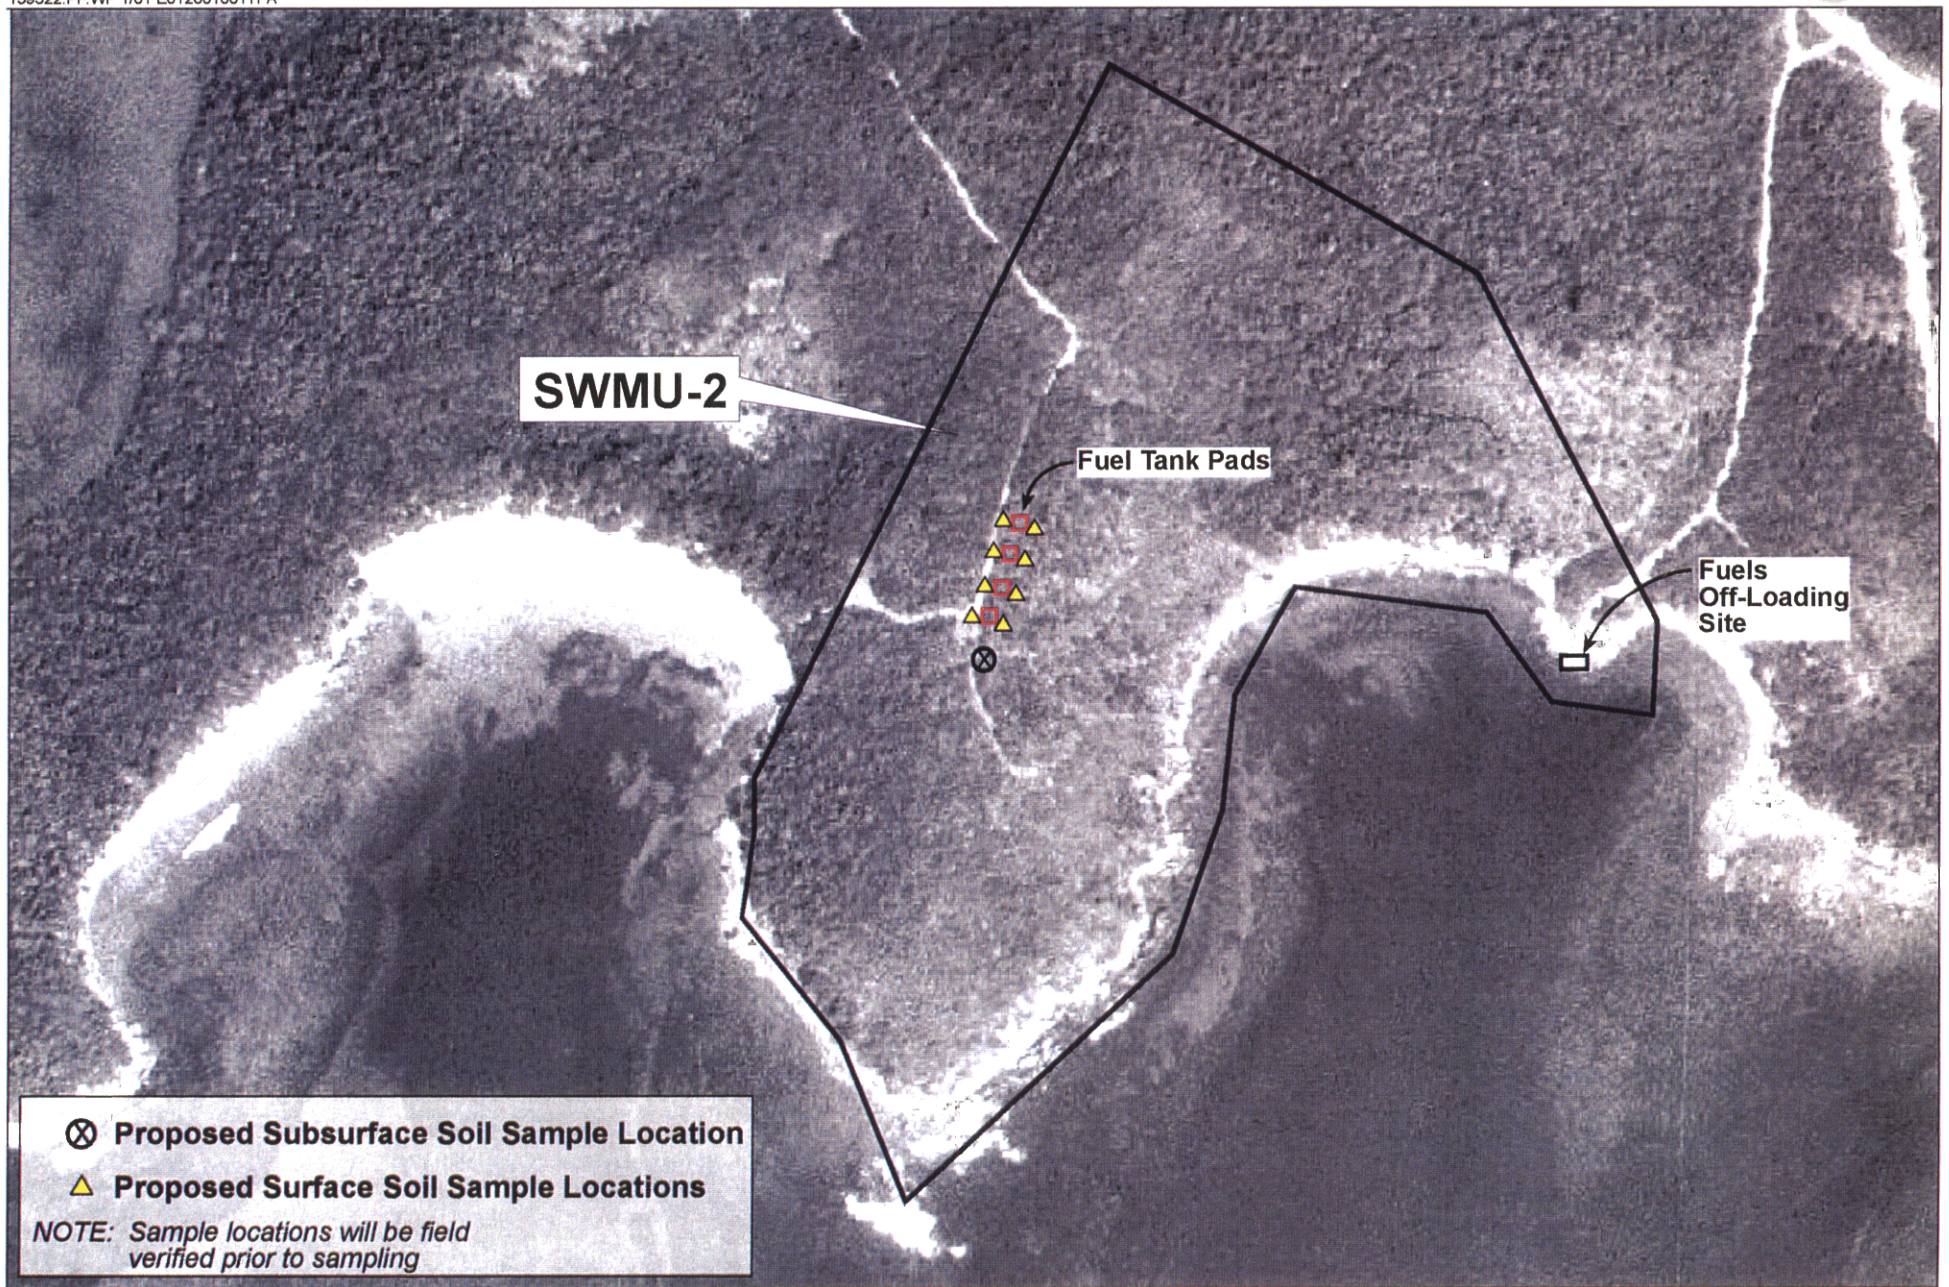
Figure 2-3
SWMU 02 PROPOSED SAMPLE LOCATIONS
FUEL TANK PADS (CAMP GARCIA)
Vieques Island, Puerto Rico

Based on the review of the limited information available for the site, CH2M HILL will collect 12 surface soil (0 to 6 inches) samples and install two soil borings at locations illustrated on Figures 2-3 and 2-4. Eight surface soil samples will be collected and one soil boring will be installed from the area of the four fuel tank pads (two surface soil samples from each pad area) as shown in Figure 2-3. The ERI aerial photograph interpretation and existing concrete pads will be used to identify the former tank locations and soil sampling locations. Four surface soil samples will be collected and one soil boring will be installed near the two fuel pipe supports in the concrete ramp area (two surface soil samples from each pipe support area) as shown in Figure 2-4. The soil borings will be installed to 15 feet below land surface (bls) and soil samples will be screened continuously with an organic vapor analyzer (OVA). Three samples with the highest OVA values will be submitted for laboratory volatile organic compound (VOC) and semi-volatile organic compound (SVOC) analysis. Surface soil samples will be analyzed for Appendix IX constituents and explosives. Although historical information for SWMU 2 does not indicate the potential presence of explosives or related residues at this site, explosives are included in the sample analyses because of the use of explosives in the range areas of the AFWTF, the potential for airborne migration of explosives residues via fugitive dust emissions, and the public concern of explosives and related residues at the AFWTF.

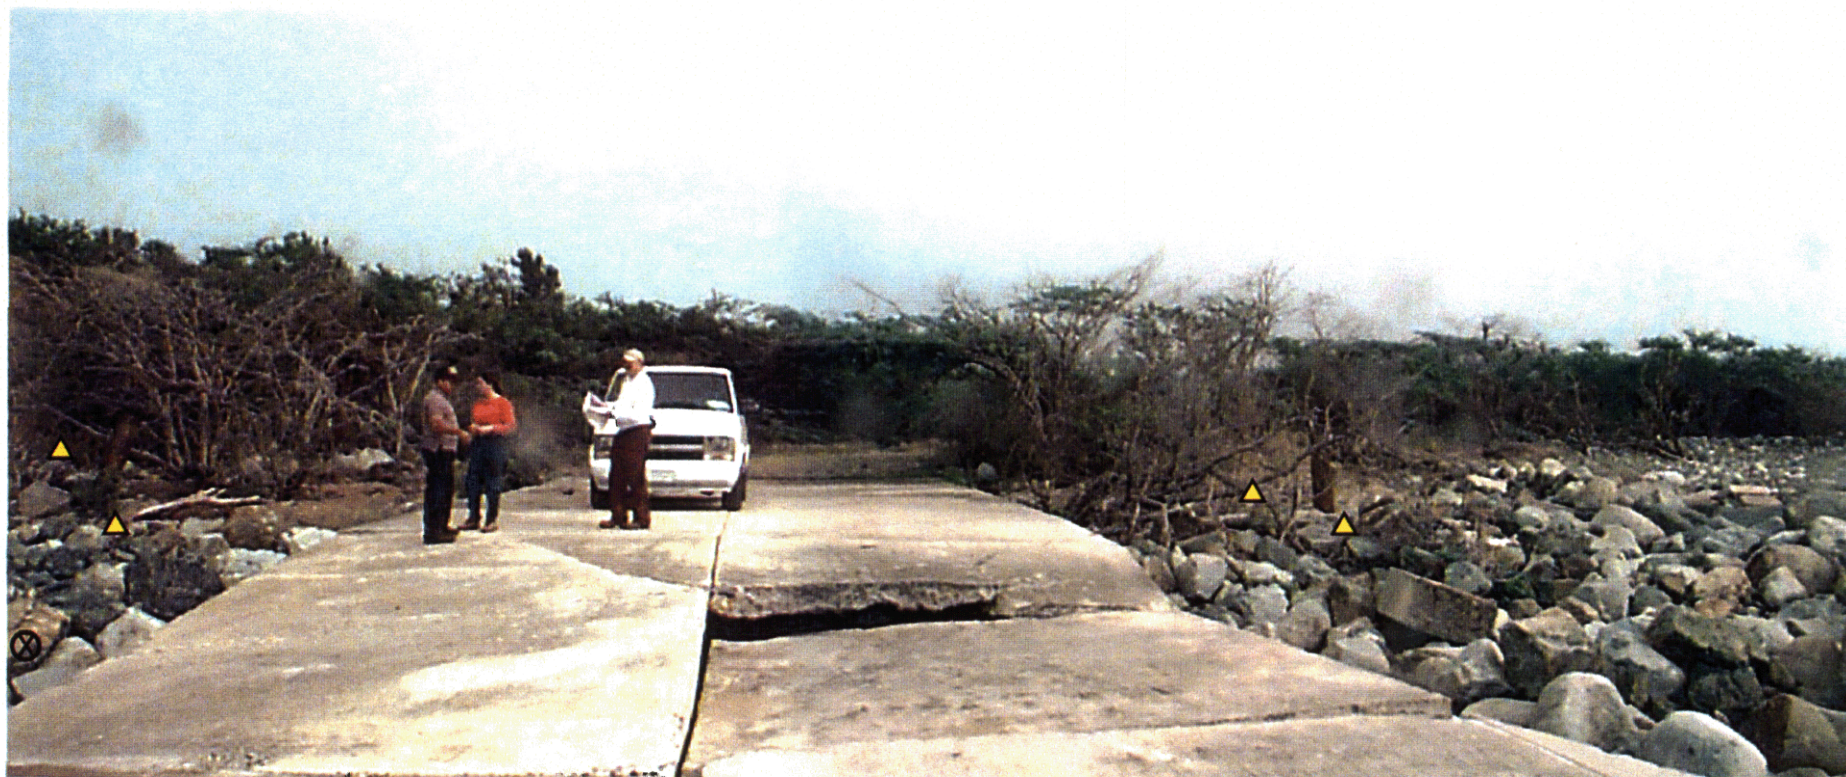
Figure 2-4
SWMU 02 PROPOSED SAMPLE LOCATIONS
FUELS OFF-LOADING SITE (CAMP GARCIA)
Vieques Island, Puerto Rico

- ▲ Proposed Surface Soil Sample Location
- ⊗ Proposed Subsurface Soil Sample Location

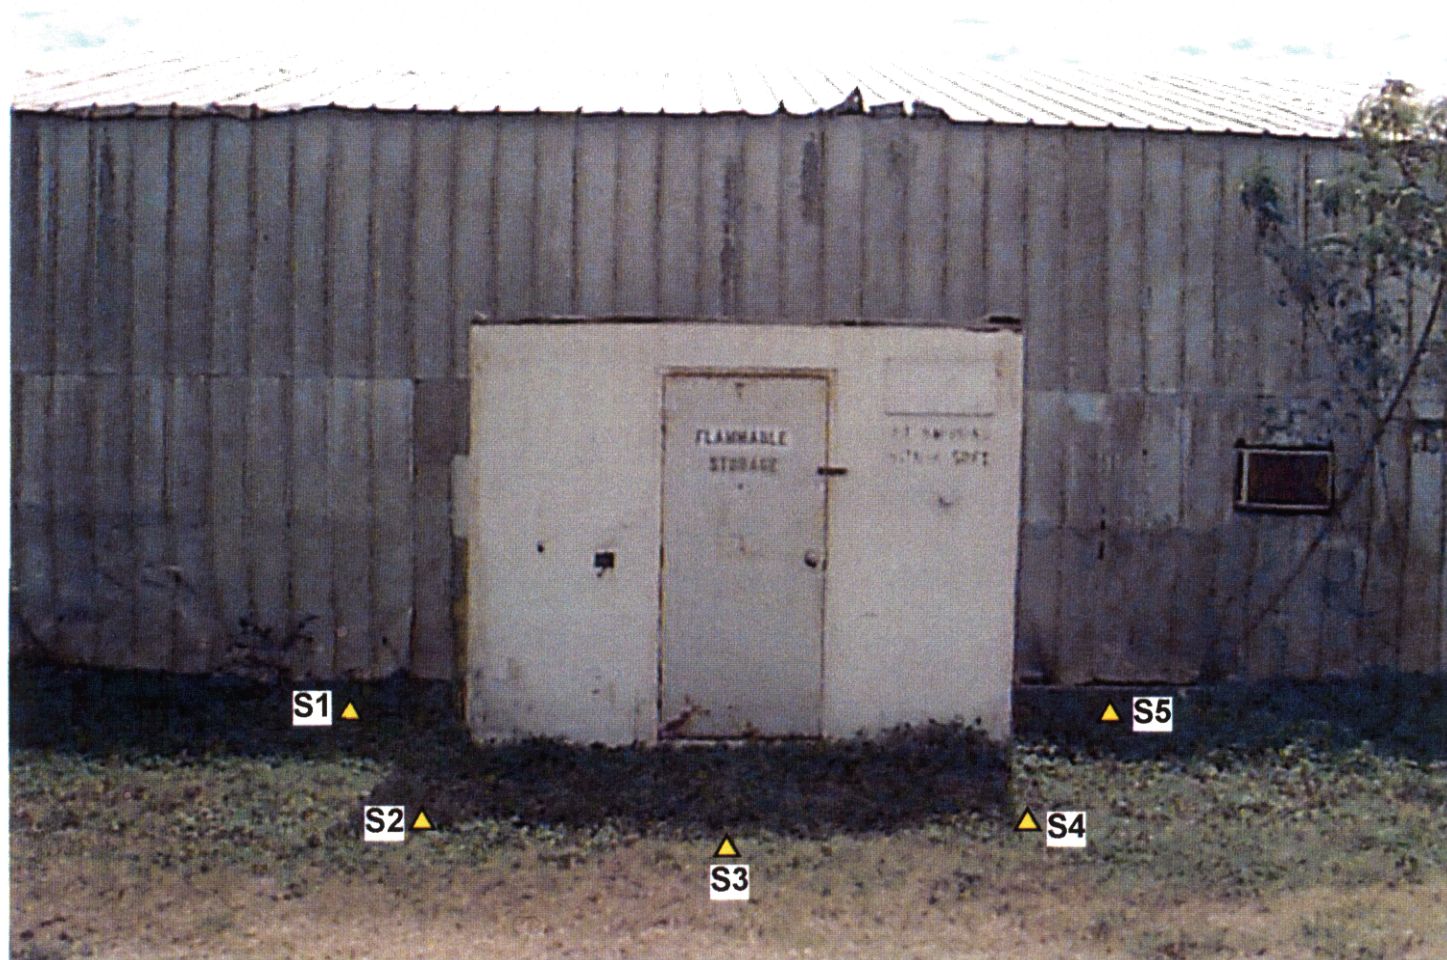
Figure 2-7
SWMU 04 PREVIOUS SAMPLE LOCATIONS
FLAMMABLE STORAGE SHED
Vieques Island, Puerto Rico

▲ Sample Location
*Proposed soil boring to be installed
if degreasing basin is found.*

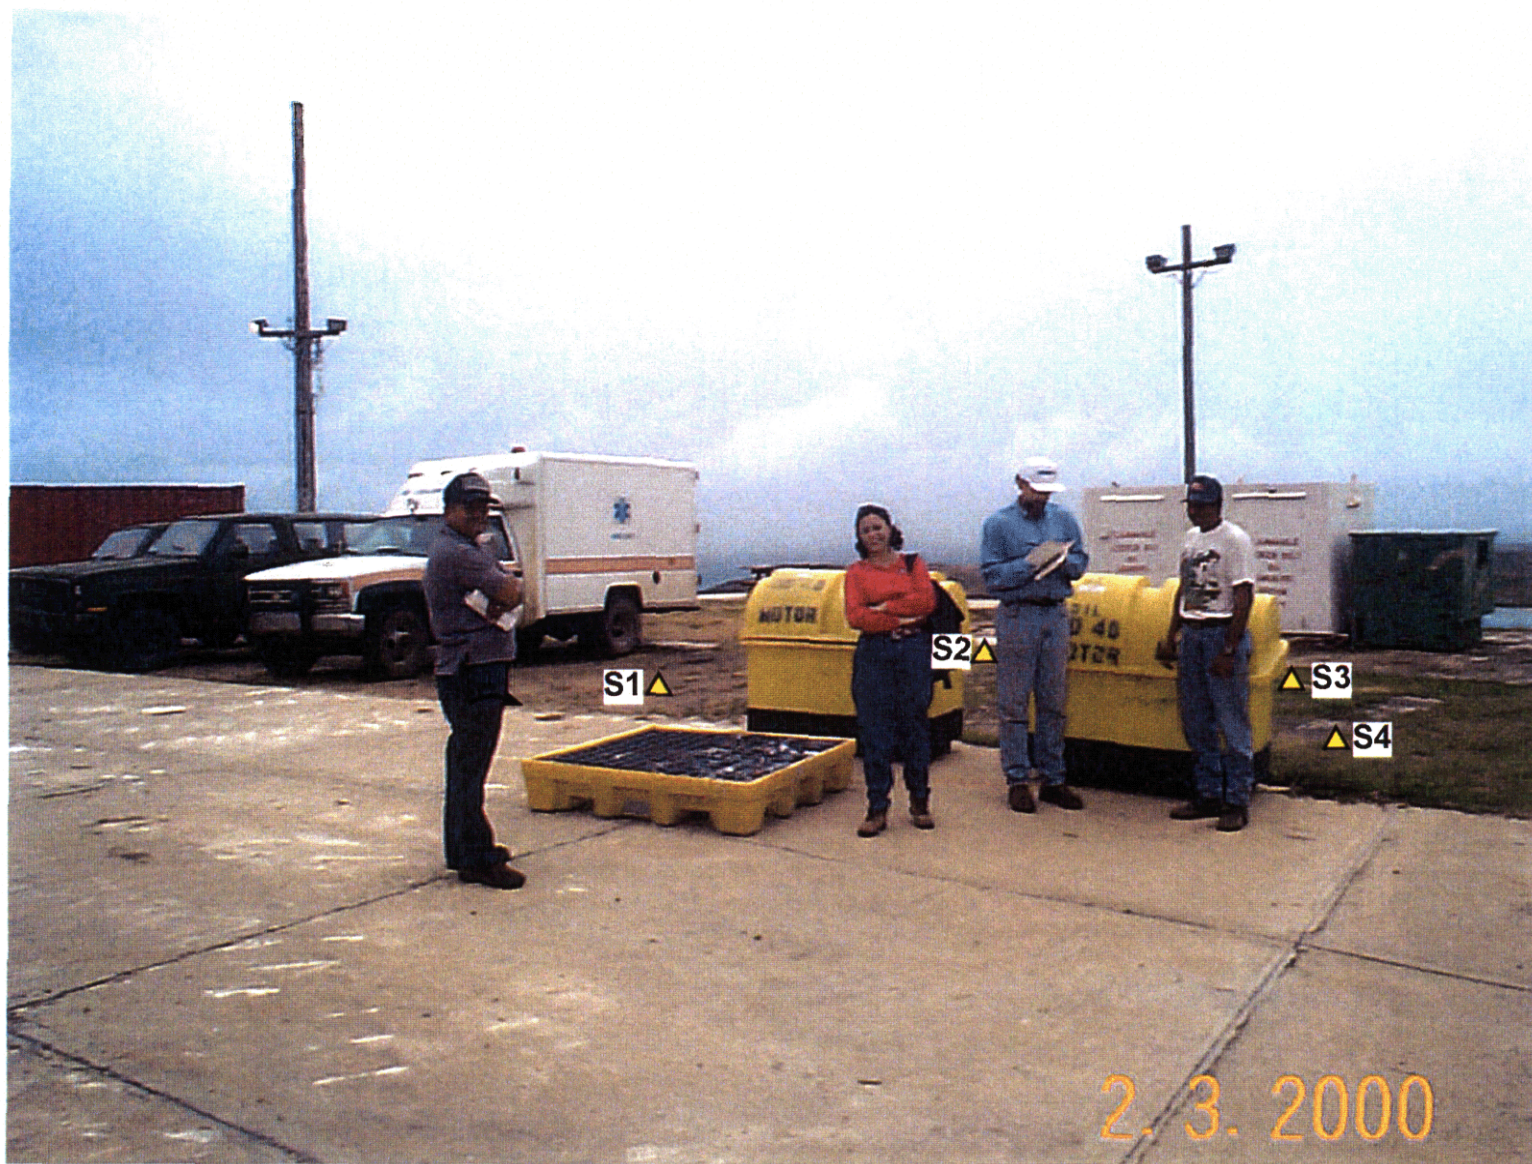
Figure 2-8
SWMU 05 PROPOSED SAMPLE LOCATIONS
SPENT BATTERY ACCUMULATION AREA
(OBSERVATION POST 1, INNER RANGE, AFWTF)
Vieques Island, Puerto Rico

Based on the review of the limited information available for the site, CH2M HILL will collect four surface soil samples (0 to 6 inches) at the locations shown in Figure 2-8. Samples will be analyzed for Appendix IX constituents and explosives. Although historical information for SWMU 5 does not indicate the potential presence of explosives or related residues at this site, explosives are included in the sample analyses because of the use of explosives in the range areas of the AFWTF, the potential for airborne migration of explosives residues via fugitive dust emissions, and the public concern of explosives and related residues at the AFWTF.

▲ Proposed Surface Soil Sample Location

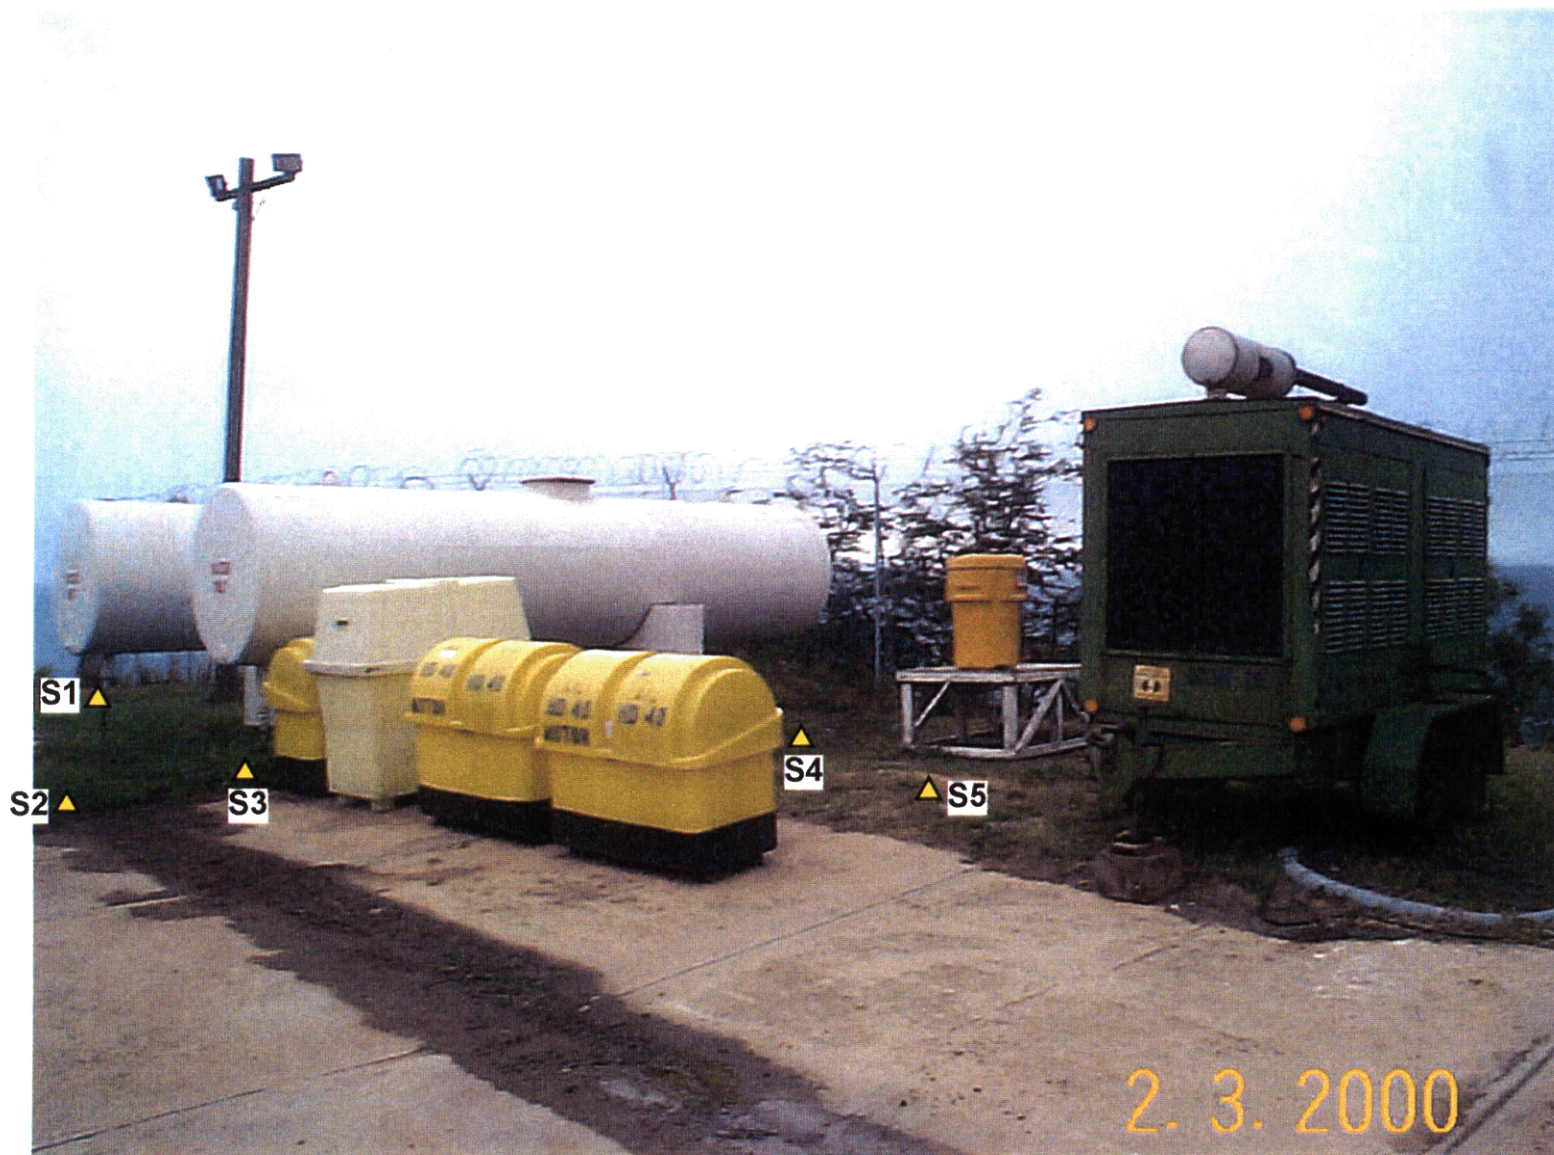
Figure 2-10
SWMU-08 PROPOSED SAMPLE LOCATIONS
WASTE OIL AND PAINT ACCUMULATION
(OBSERVATION POST 1, INNER RANGE, AFWTF)
Vieques Island, Puerto Rico

Based on the review of the limited information available for the site, CH2M HILL will collect five surface soil samples (0 to 6 inches) in the locations shown in Figure 2-10. Surface soil samples will be analyzed for Appendix IX constituents and explosives. Although historical information for SWMU 8 does not indicate the potential presence of explosives or related residues at this site, explosives are included in the sample analyses because of the use of explosives in the range areas of the AFWTF, and the public concern of explosives and related residues at the AFWTF.

▲ Proposed Surface Soil Sample Location

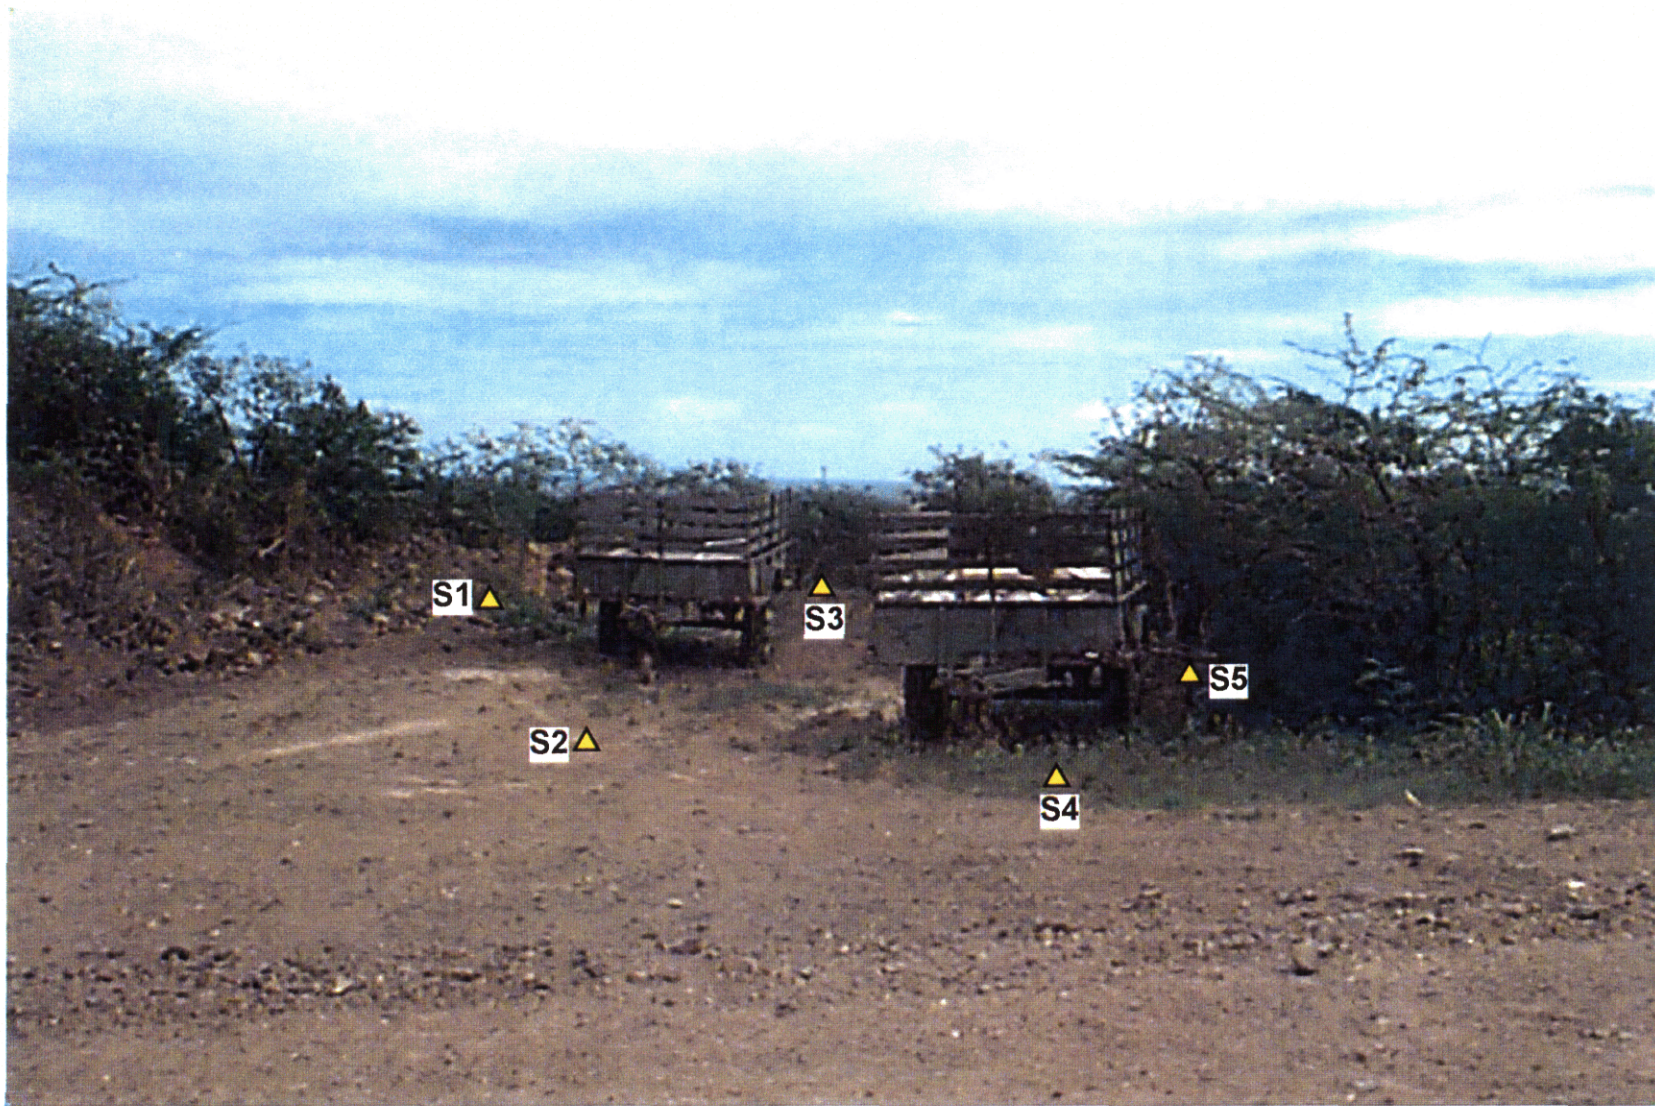
Figure 2-13
SWMU 12 PROPOSED SAMPLE LOCATIONS
SOLID WASTE COLLECTION UNIT AREA
(OBSERVATION POST 1, INNER RANGE, AFWTF)
Vieques Island, Puerto Rico

Based on the review of the information available for the site, CH2M HILL will collect five surface soil samples around the waste collection units as shown in Figure 2-13. Samples will be collected from a depth of 0 to 6 inches, and the results will be used to determine if a release of hazardous materials has occurred at the site. Soil samples will be analyzed for Appendix IX constituents and explosives. Although historical information for SWMU 12 does not indicate the potential presence of explosives or related residues at this site, explosives are included in the sample analyses because of the use of explosives in the range areas of the AFWTF, and the public concern of explosives and related residues at the AFWTF.

▲ Proposed Surface Soil Sample Location

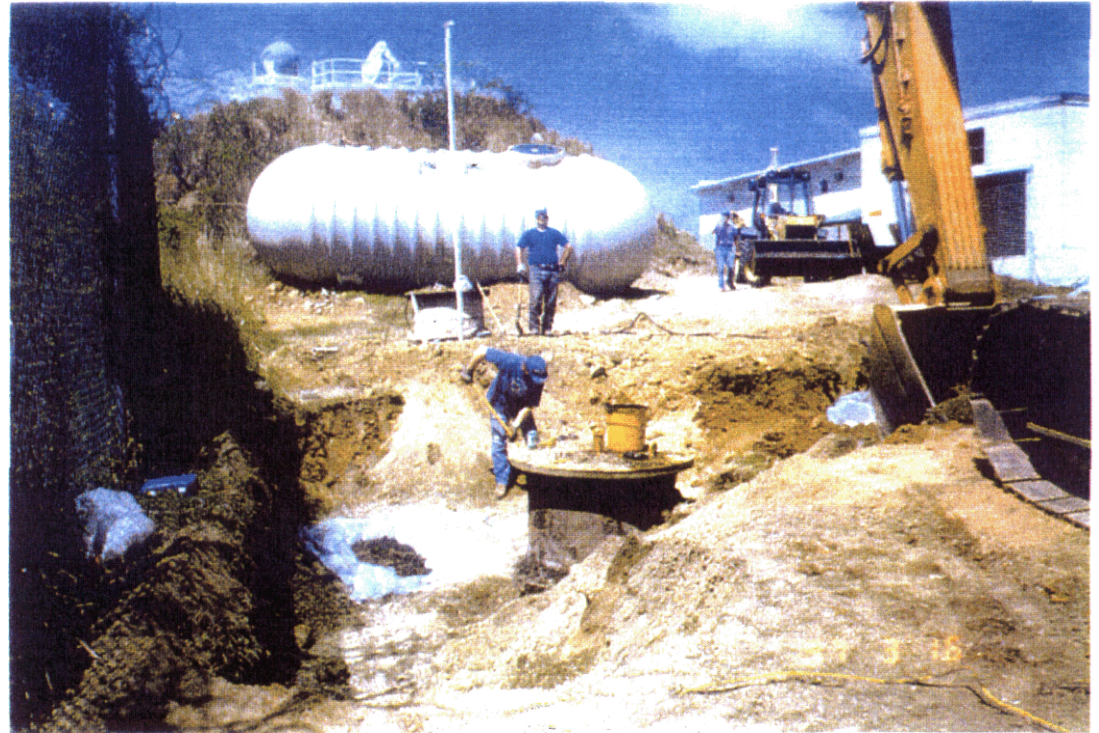
Figure 2-15
AOC A DIESEL FUEL FILL PIPE AREA
SOILS EXCAVATED DURING REPLACEMENT OF UST
(OBSERVATION POST 1, INNER RANGE, AFWTF)

The UST, associated piping including the fill pipe, and surrounding soil were excavated and removed for disposal in 1997. Four confirmation soil samples were collected from the excavation and analyzed for petroleum-related constituents. No petroleum-related constituents were detected in any of the four soil samples. The UST was replaced with a new UST. The closure report describes where the four samples were collected, but does not include sample collection depths or actual collection locations. Appendix A provides the UST Removal Closure Report. The closure report was not prepared until April 2000 after comments were received from PREQB.

The confirmation soil sampling conducted during the 1997 UST replacement at the site did not indicate the presence of any petroleum-related constituents. Figure 2-15 shows the area of the tank replacement and excavation of soils.

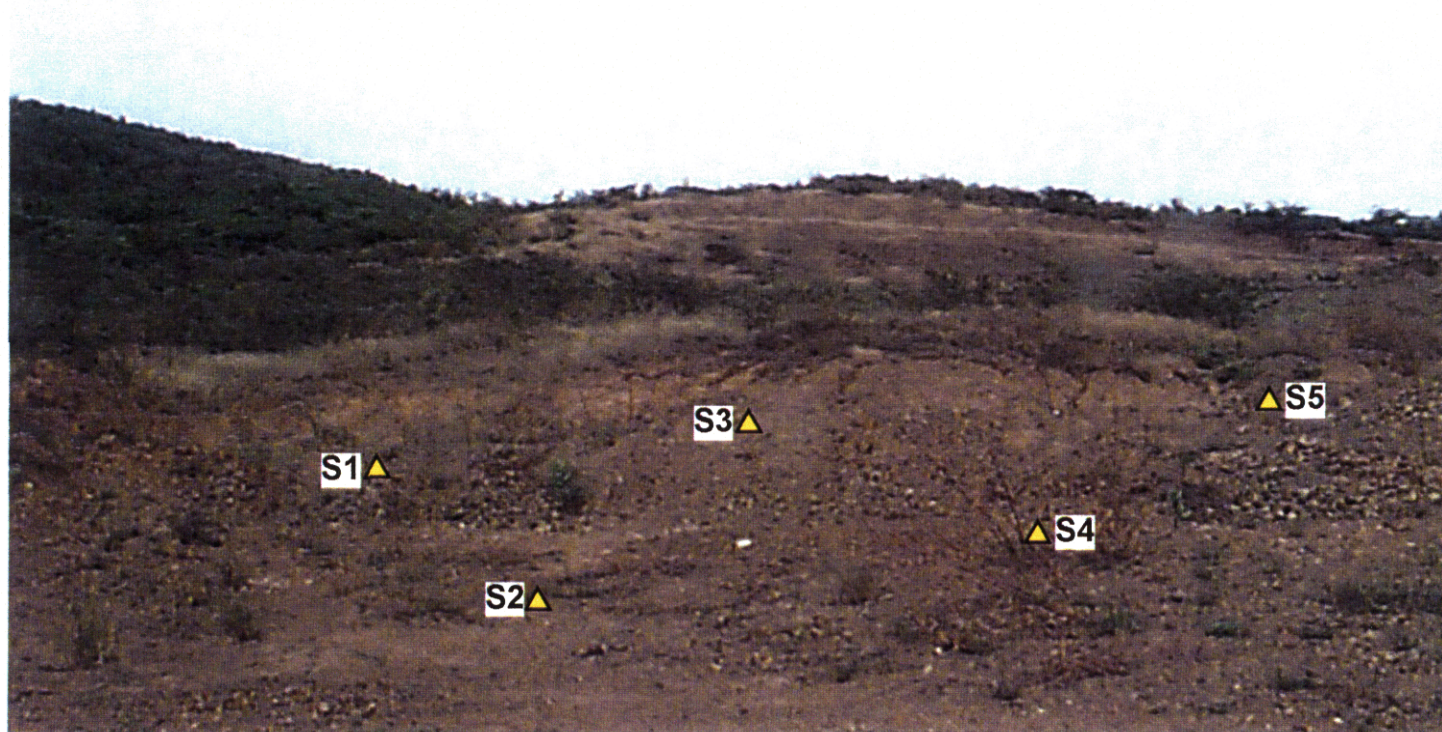
Figure 2-17
AOC F PREVIOUS SAMPLE LOCATIONS
ROCK QUARRY (CAMP GARCIA)
Vieques Island, Puerto Rico

Because of the transfer of activities from NASD to Camp Garcia, the rock quarry may continue to be used for road maintenance activities. CH2M HILL conducted an investigation in June 2000 to determine if hazardous constituents existed in the surface soil where Navy personnel will remove quarry material. Five surface soil samples were collected from the areas illustrated in Figure 2-17. The samples were analyzed for Appendix IX parameters and explosives. Analytical results from this effort were provided in the August 1, 2000, Quarterly Report and will be included in the Phase I RFI Report. The surface soil sampling results indicated that only arsenic was detected above RBCs. As discussed throughout this document, the presence of arsenic in the soil is likely to be naturally occurring given the volcanic origin of the soils on the island.

▲ Previous Surface Soil Sample Location

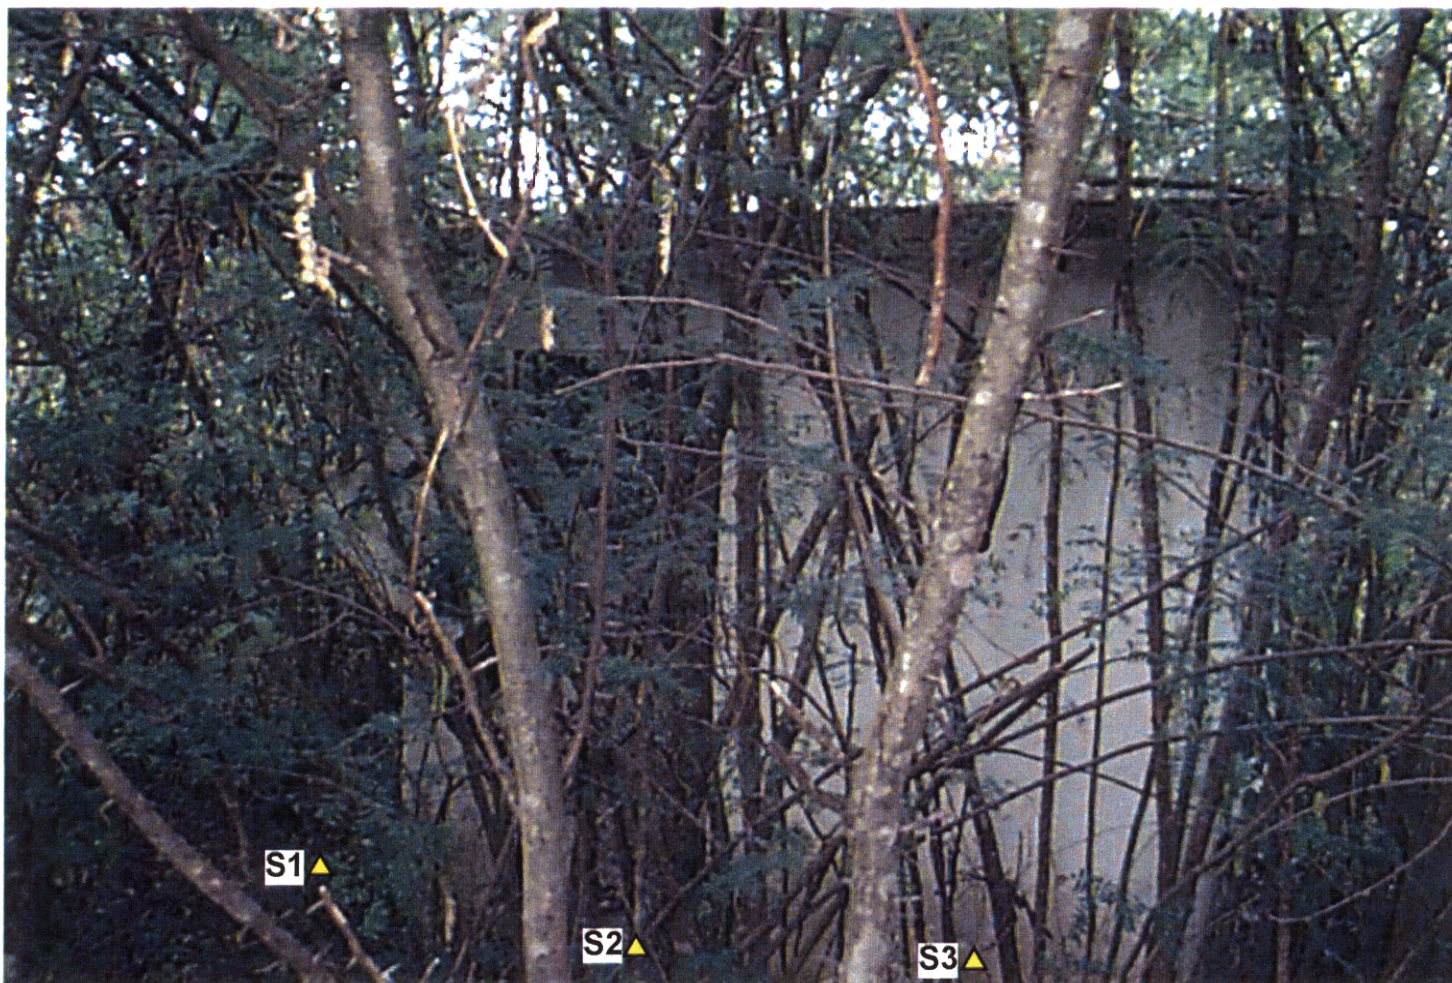
Figure 2-19
AOC G PROPOSED SAMPLE LOCATIONS
PUMP STATION AND CHLORINATION BUILDING
AT SEWAGE LAGOONS (CAMP GARCIA)

Based on the review of the information available for the site, CH2M HILL will collect five surface soil samples in the area of the chlorination building and the nearby chlorine contact chamber as shown in Figures 2-19 and 2-20. The surface soil samples will be collected from a depth of 0 to 6 inches, and the results will be used to determine if a release of hazardous materials has occurred at the site. The surface soil samples will be analyzed for Appendix IX constituents and explosives. Although historical information for AOC G does not indicate the potential presence of explosives or related residues at this site, explosives are included in the sample analyses because of the use of explosives in the range areas of the AFWTF, and the public concern of explosives and related residues at the AFWTF.

▲ Proposed Surface Soil Sample Location

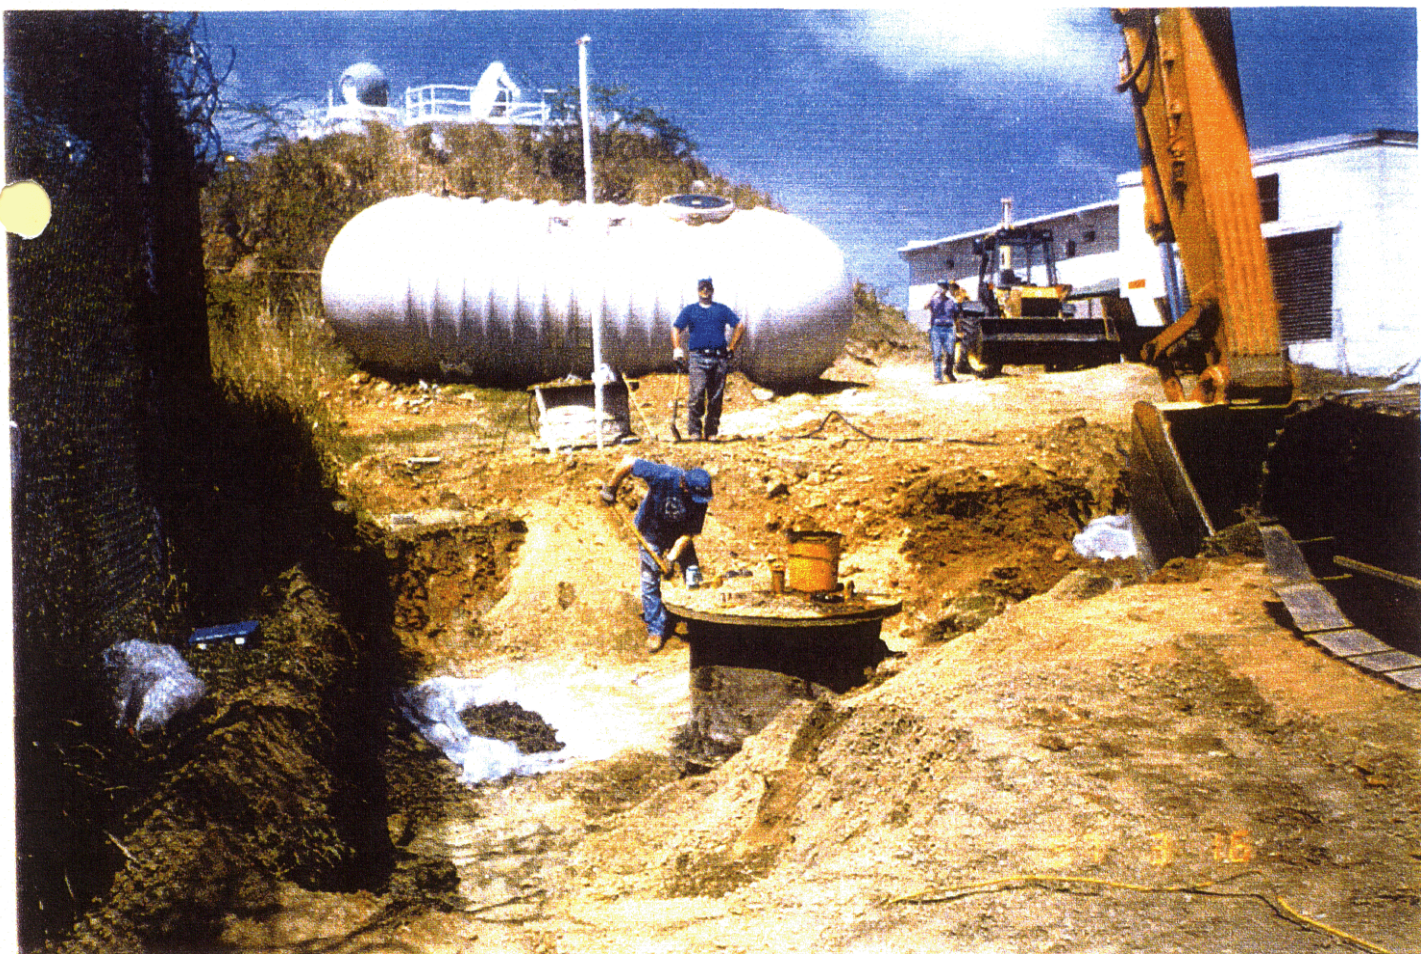
Excavation of Tank 1005 July 1997
